Re-FIT: Repair bushings with Front Infusion Technology

Pro-active We4Ce development due to premature blade root damages seen on-site

14 September 2021

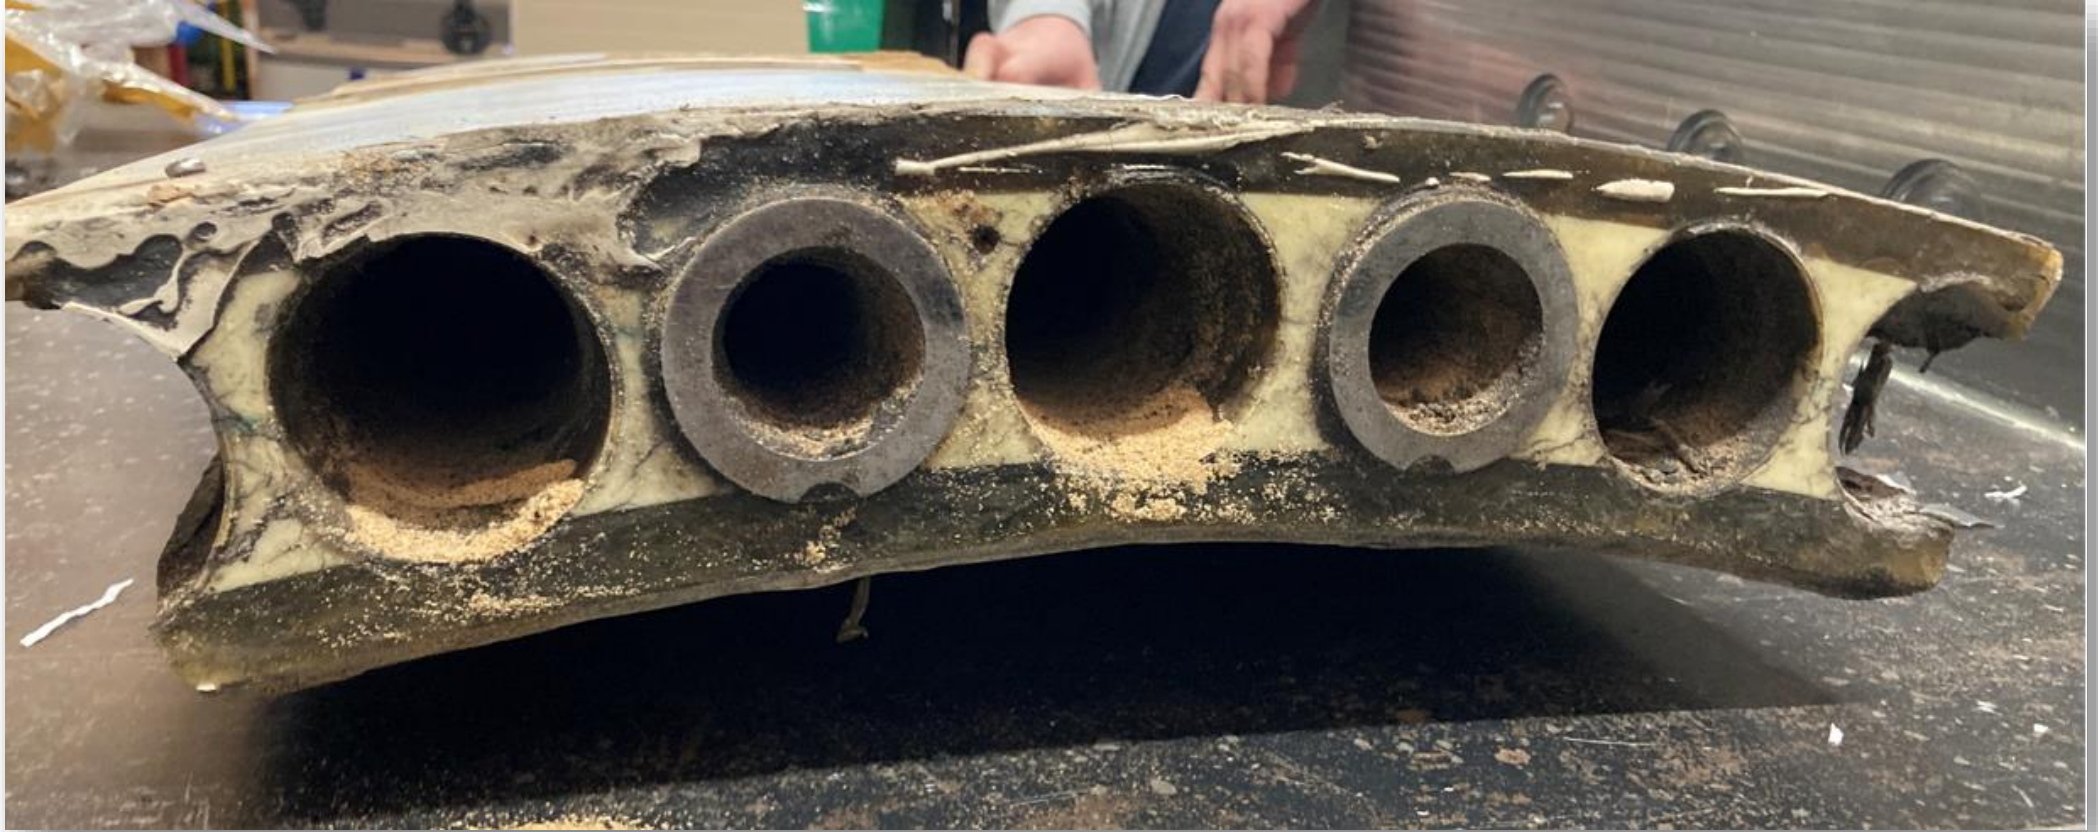
Root which is affected in the bushing area

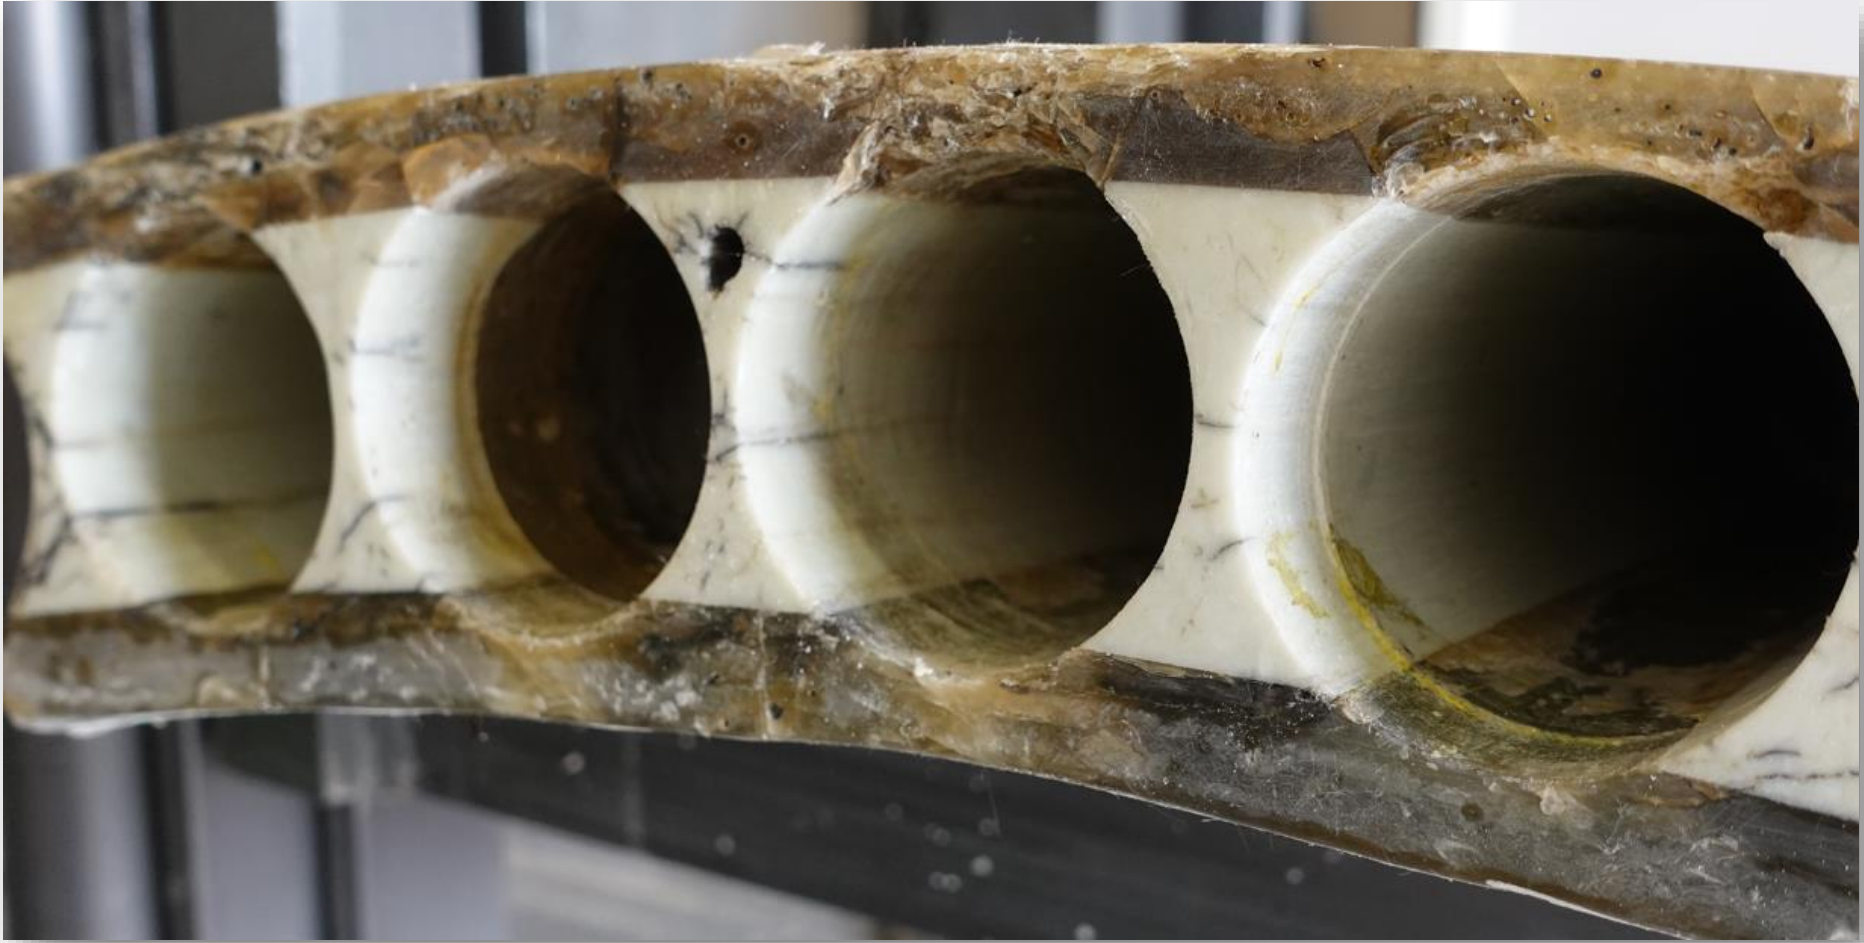
After removing of the bushings

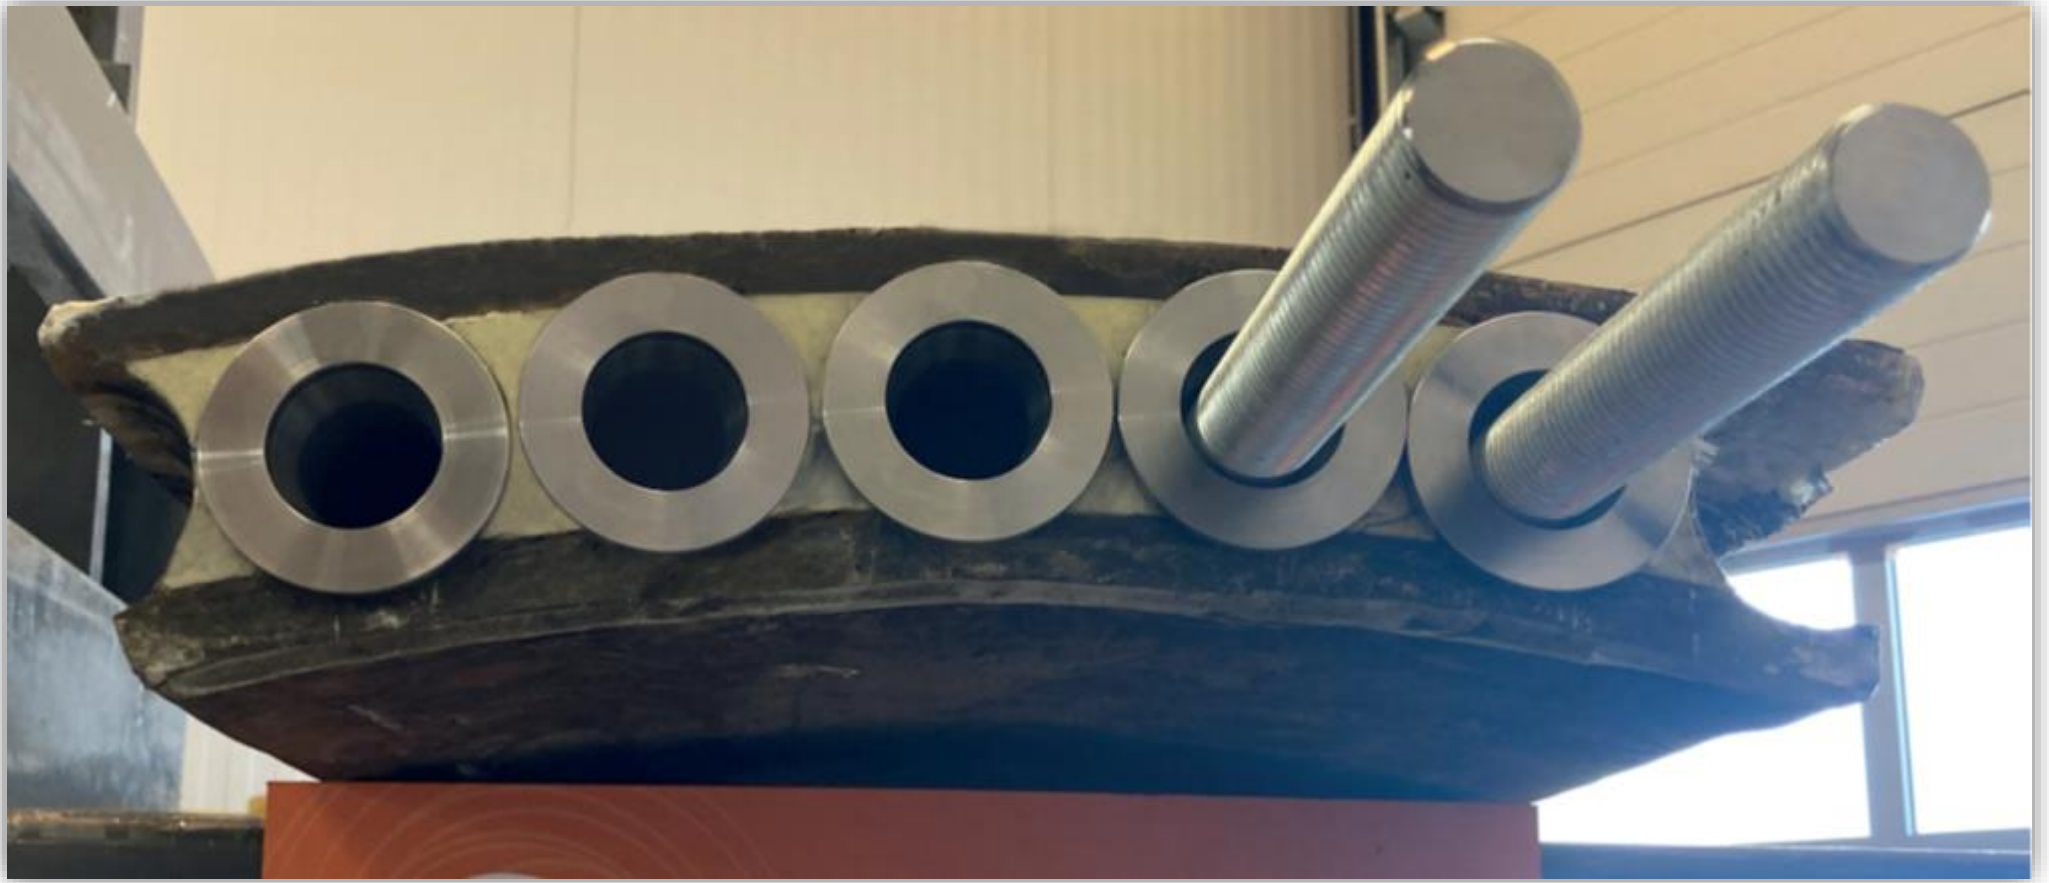
After Re-FIT

Re-FIT Bushing Solution → Controlled repair method by removing and replacing only the affected part. For higher repair volumes.

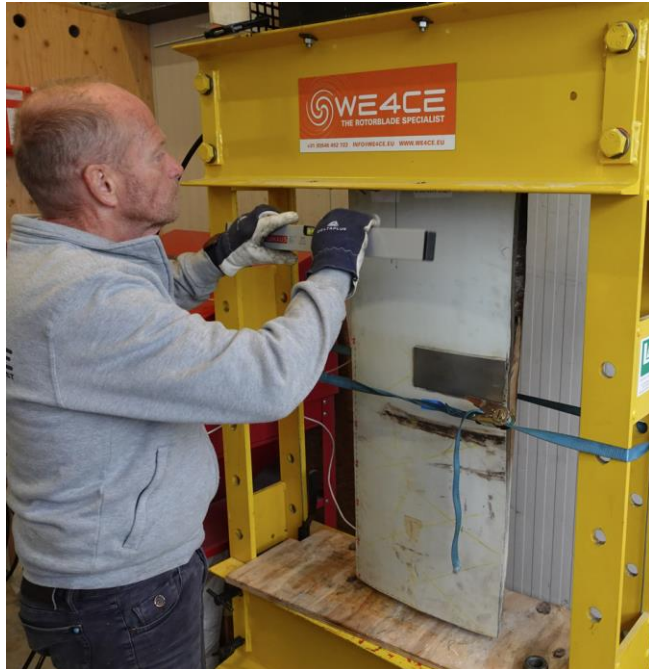
We4Ce 50Ton rig

We4Ce Accomplished Successfully the Confidence Tests M30 Re-FIT Blade Root

A: Limited extreme test up to 400kN

B: 1M cycles fatigue: 32.5-325kN

C: Extreme test to failure: 630kN
(+11% above 10.9 bolt strength)
